Analysis of Tapial structures for modern use and conservation

P.A. Jaquin, & C.E. Augarde

The building under investigation here is the Preceptory at Ambel, Zaragoza in northern Spain which dates from the 10th century. (Part of the building is shown in Figure 1). It is made almost entirely from Rammed Earth (Tapial) and Adobe bricks. The ar-

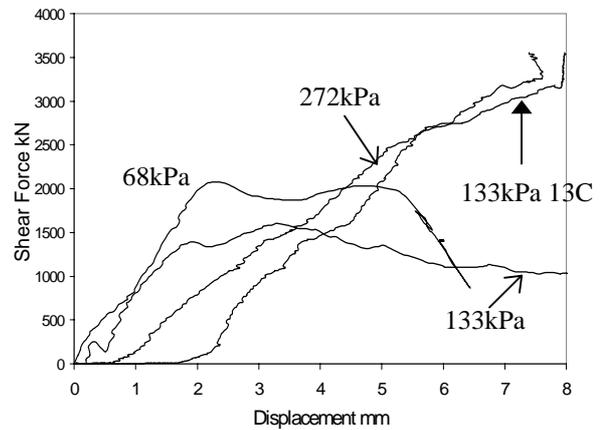
Figure 3: Shear box test results for rammed earth samples

The results are inconclusive as the plots of shear stress against displacement in Figure 3 shows. Three tests were carried out on samples thought to date from the 19th century and one on a 13th century sample. In the latter samples, a lower peak shear strength is reached in the sample subjected to a higher normal stress, contrary to expectations for standard frictional materials. For example, predicted angles of friction for the first two samples are 83° and 72° indicating bonding to be significant. The 19th century sample at the highest normal stress, however, does not show a peak strength within the range of testing carried out. The 13th century sample also fails to show a peak strength.

These limited set of tests show that rammed earth is clearly not a simple frictional material but could be regarded as a frictional bonded soil. Clearly a comprehensive sampling and testing programme is required to confirm properties of this material that can be used reliably.

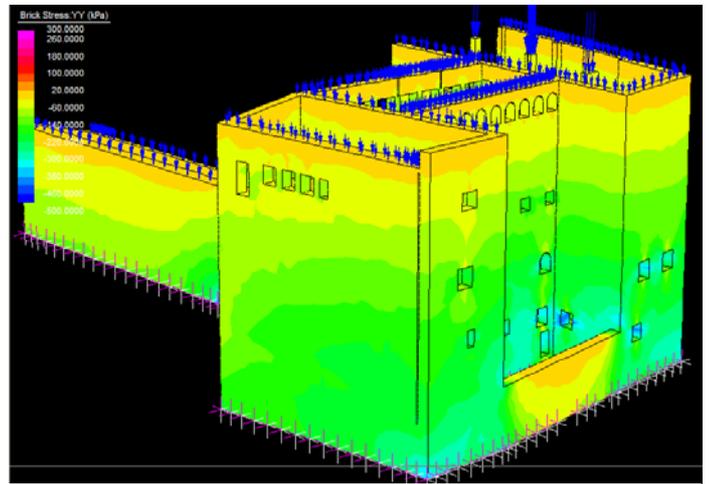
Figure 4: FE model of the building with vertical normal stress contouring

As an example of the FE modelling, Figure 4 shows the outline of the finite element model used with vertical stresses due to roof loading only and gravity. The stresses range from 0.3 MPa to –0.5 MPa with tension positive. It can be seen that the stresses generally increase down the building, due to the high self-weight of the walls.

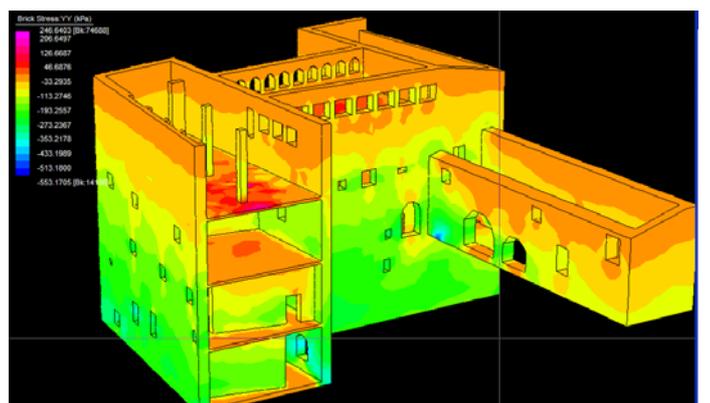
Figure 5: FE model view of the rear of the building

Figure 5 shows the building from the south, and detailed inspection reveals raised levels of tensile stress between columns of the windows at the top of the building, and also at the floor area around the rear column in room 302. Although the vertical stresses are plotted, the floor is also carrying sub-

stantial stresses in the other two directions. The high stresses at this location are due to the floor acting as a transfer beam, as there is no support below. It can be seen by looking at the original plans that this wall is part of a 13th century tower which has been consumed by the building of the 18th century part (that part below room 303). Undoubtedly some of the effects are caused by the idealisations assumed in the modelling, especially the introduction of the cut line to the model. On a practical level, however, the model demonstrates that this floor should be checked for cracking and deformation, as the whole column load is being transferred through this floor.

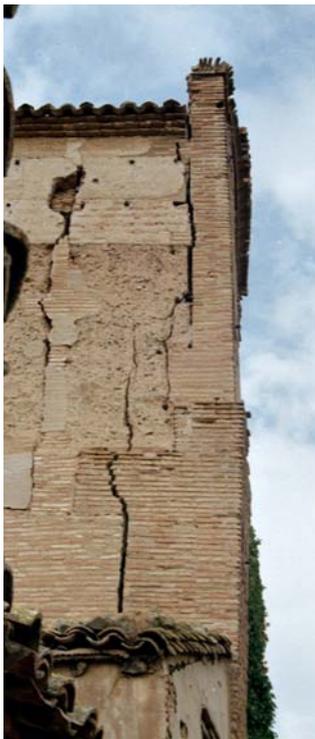
Figure 6: View of major crack in the NE wall

Figure 6 shows the northeast wall of the building where a major crack is visible. This appears to be the worst crack in the building. Externally, the crack runs between the brick quoins which form the corners of the building, but at around 2/3rds height the main crack stops and another crack extends upwards through the brickwork and into the exposed earth. A further crack is visible to the left, running through the earth, but this is not visible within the building. The wall was built in a number of stages and has also been subjected to numerous repairs and alterations. The base of the wall was built around 1380 and extends the full distance across the front of the building. A second level was built sometime before 1550 and is fronted entirely with brick, although

there appears to be a step just to the left of the ivy. A third building phase resulted in brick quoins extending the full height, with a rammed earth wall in between. This final stage actually extended one storey higher than at present and was removed during the building renovation in 1796 (Gerrard 2003)

The bottom of the north wall is leaning forward slightly when compared to the adjacent building in which was constructed in 1960 which can be assumed to be vertical. It is assumed that the next stage of building commenced onto an already leaning wall, and that the top sections of the wall are indeed vertical. There is however the possibility that the top of the north wall is falling forward, away from the building as it does not appear tied to the other walls at the top. It is assumed that originally the top storey tied the north wall into the structure, but following the removal of the top storey, the north wall is now unsupported.

There is also no connection between the floors and the north wall as the ceiling beams run east-west, tying the east and west walls together, but allowing the north and south walls to act independently. These rooms have been used as granaries for most of their lives, therefore will have been subjected to high loading and unloading cycles, and the floor could easily have failed given the high loading. However the cracking pattern in the floor is not consistent with slab failure given a load on the whole area, but is consistent with the floor being loaded very unevenly.

The top storey was removed in order to prevent major structural collapse (Gerrard 2003). This would indicate that the cracking in the east wall were already present. What is not known is if the cracking has been stopped or dramatically reduced since 1796, is the crack 'stable'. This can partly be guessed at by looking at the floor pattern in room 237 which reveals that there have been two major failures of the floor, with the tiling pattern changes indicating a repair. Therefore it can be assumed that the floor failed first in the centre of the room and was repaired, although beam failure rather than wall movement may have caused this collapse. Secondly the floor failed again, the crack is still present, and has been repaired by the placing of a wooden beam into the western wall. This repair probably occurred around 1800 although it is difficult to date exactly.

The reason for the initial crack is difficult to pinpoint, but one reason could be settlement of the made ground on which the wall is based. The land is sloping gently down to the north, with a made stone base upon which the rammed earth wall is built. A stream has been running across the north of the site for at least 1000 years, and while this is not very large, it is conceivable that this stream may have caused erosion, flooding or other activity leading to subsidence of the ground immediately under the tower. As the ground is already sloping, it is conceivable that the original builders made the level up in order to build the first level of the wall, which acted as a one storey building, and backs onto solid rock. After a number of years this wall was built up to three storeys, then again built up to 5 storeys. From the change in angle, it can be seen that the leaning forward of the wall occurred before 1380 and following this around 1550 the remainder of the wall was built.

The best method to prevent the cracks propagating is to pull the two surfaces closer together, but this must be done in such a way that no further harmful stresses are developed. At present there is little published material on the structural stabilisation of rammed earth structures, although much has been published on new build, and there are many specific examples of restoration work. The present solution involves the bolting of steel I beams to the transverse roof timbers, which are then tensioned against H shaped bars fixed against the outside of the building. This solution, while appearing to work, is not ideal, in that the whole overturning force of the north wall is taken on the timber beams, and that there is a large visual impact on the front of the building.

The authors considered a number of solutions. Grouted reinforcement bars could be inserted into the north wall and travel through into the east wall. These bars could either be anchored externally in a similar fashion to the H bars present at the moment, or may be able to provide enough resistance though application of grout.

earth structures, and tests would have to be carried out in order to ascertain the pullout strength of the reinforcement bar (the tensile capacity of the joint) and the effect of drilling a long hole into rammed earth. However this solution would prevent the load being transferred to the roof beams, and should be considered if there appears to be any failure of the roof bolts.

A tested retrofitting technique is the application of nylon strapping to provide tensile support across the crack. This strapping would have to be bolted into place, and again the effect of bolting structural elements into existing walls has never been thoroughly investigated, but would provide an easy and cheap solution to cracking in rammed earth walls.
