# Skin friction of soil displacement threaded piles. What instrumented load test and what design norms say?

Árpád Szerző<sup>\*1</sup>

<sup>1</sup> SBR Soletanche Bachy Fundații Ltd, Bucharest, Romania

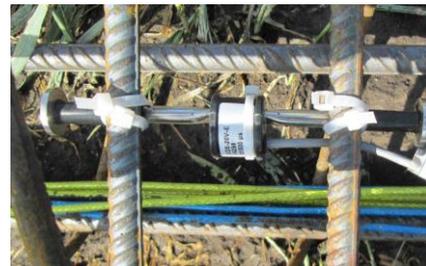
Figure 3. Strain gage installed on cage

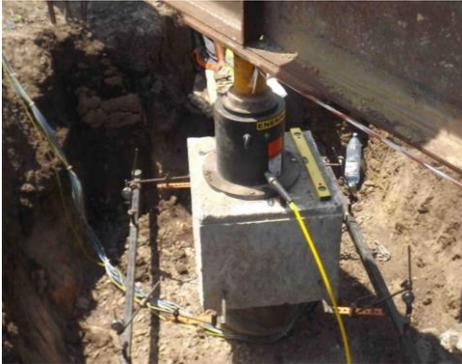
**Figure 5.** Pile head during load test.

Fig. 5 is an image of the pile head during the load test. It can be observed that the hydraulic pump applying the load is placed slightly to the "left" of the image, with sensors no. 3 and 4 being placed on the left side, further confirming the previously mentioned hypothesis for pile failure.
