Analysis of Tapial structures for modern use and conservation

P.A. Jaquin, & C.E. Augarde

The building under investigation here is the Preceptory at Ambel, Zaragoza in northern Spain which dates from the 10th century. (Part of the building is shown in Figure 1). It is made almost entirely from Rammed Earth (Tapial) and Adobe bricks. The ar-

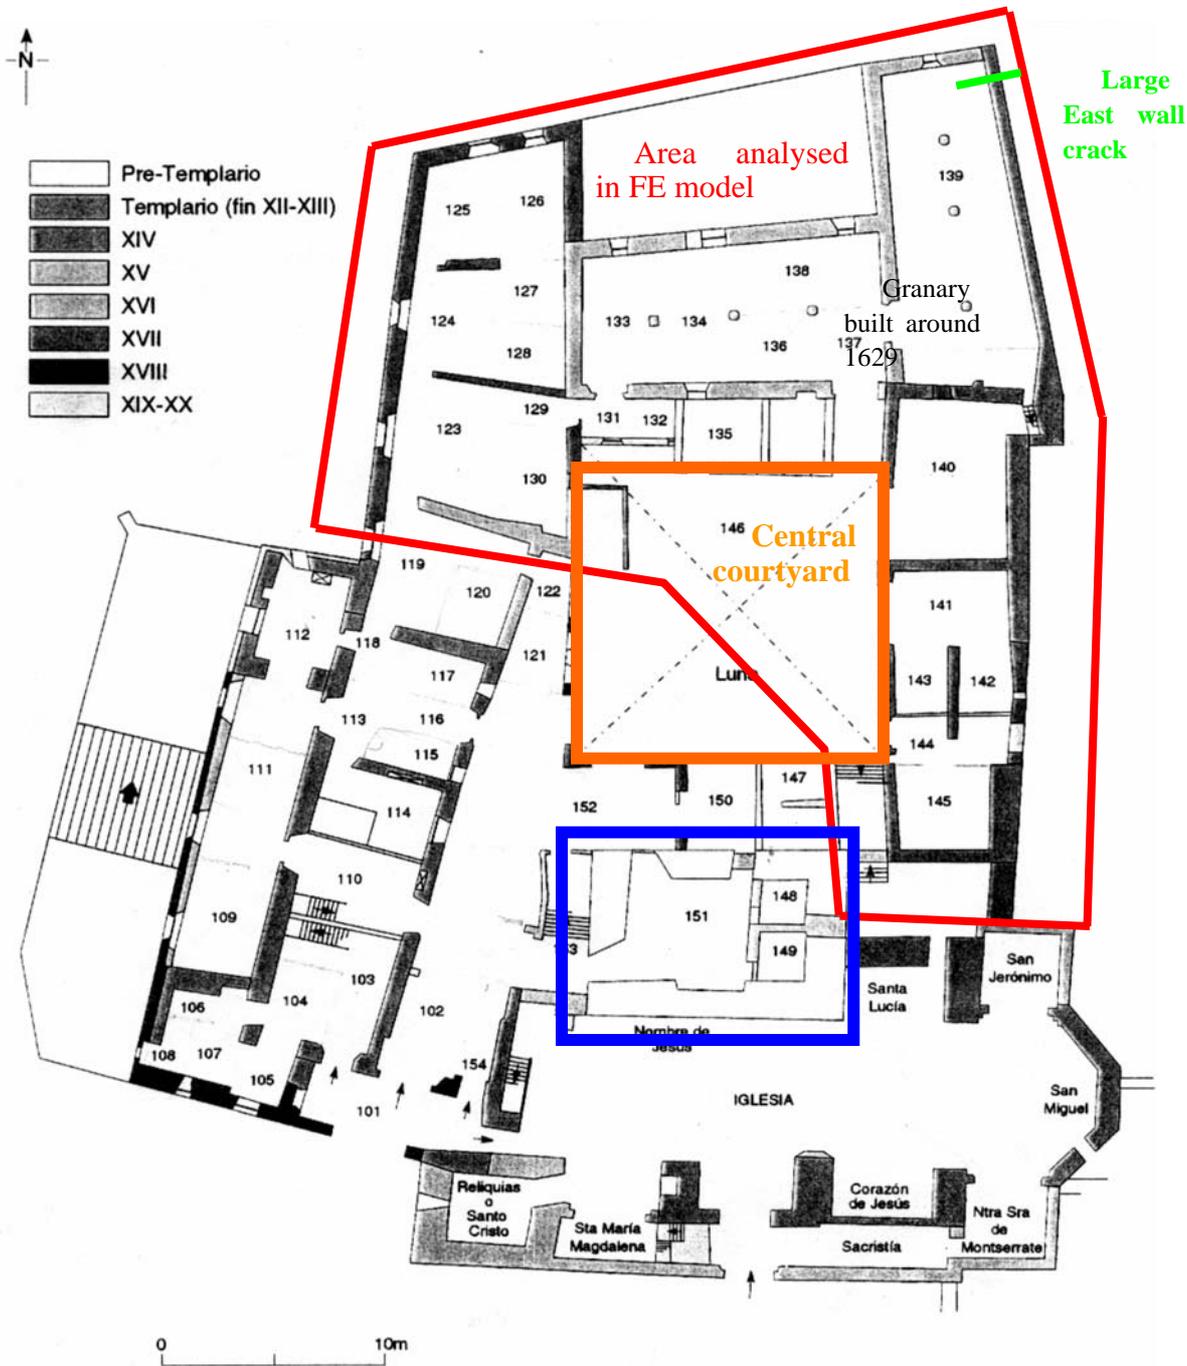
Figure 2: Plan of the Preceptory at Ambel

building remained unoccupied until the early 1990s when a number of structural works were undertaken in order to make parts of the building habitable. At present there is large crack of unknown vintage at the north end of the northeast wall and a smaller, but growing crack in the eaves of the north courtyard wall.
